Power to the birds

BUTCH ROSSOUW
SENIOR ENVIRONMENTAL
CONSULTANT
PARSONS BRINCKERHOFF

ESKOM POWER UTILITY IN SOUTH AFRICA, INITIATED A PROGRAM FOCUSING ON ENGINEERING DESIGN INNOVATION TO DEVELOP MITIGATION STRATEGIES TO PREVENT VULTURE MORTALITIES, THEREBY ENHANCING THE QUALITY OF SUPPLY.

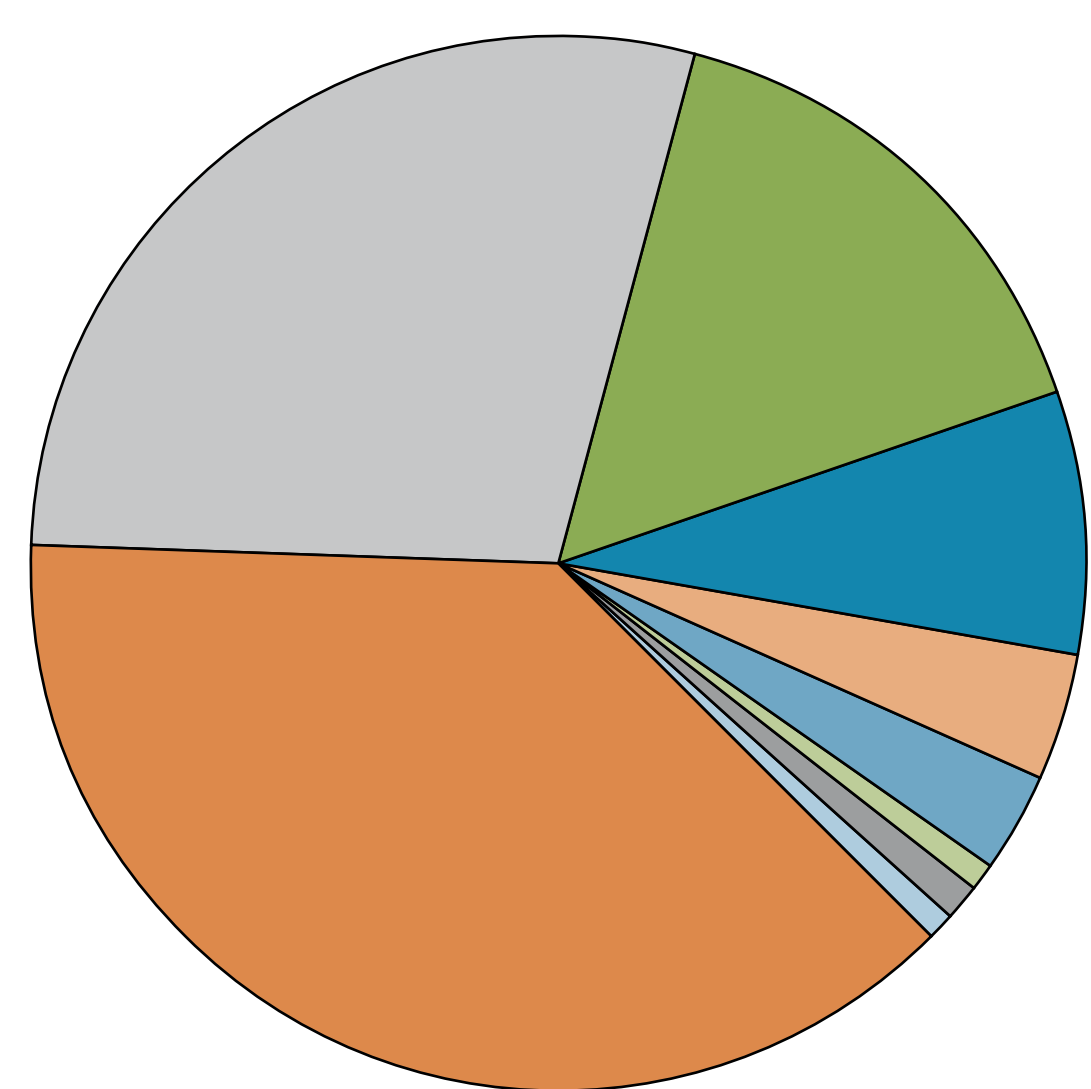
Figure 1: Summary of Transmission line faults for the period 1993-1999

Unknown 38.2%	Birds 8.1%	Hardware failure 0.9%
Storm 28.8%	Sugar cane fires 3.7%	Line faults 0.9%
Grass fires 15.6%	Pollution 3.2%	Tree contact 0.8%

Birds are not only killed by powerlines, but they also materially affected the quality of electricity supply through bird streamers. Bird streamers are long streams of conductive excreta which cause short circuits on high voltage lines. In 2000 a research team from Eskom found that up to 20% of all annual short circuits on the national Eskom high voltage transmission network were potentially caused by bird streamers (pollution) and bird electrocutions. Electrocuted birds were also the cause of numerous bushfires. It was therefore in the interest of Eskom to develop a preventative strategy through engineering design. Similar issues with low voltage power lines have been experienced in Australia.
