# Lake Mealup on the road to recovery: an adaptive management approach to acid suphate soils

### Lake Mealup

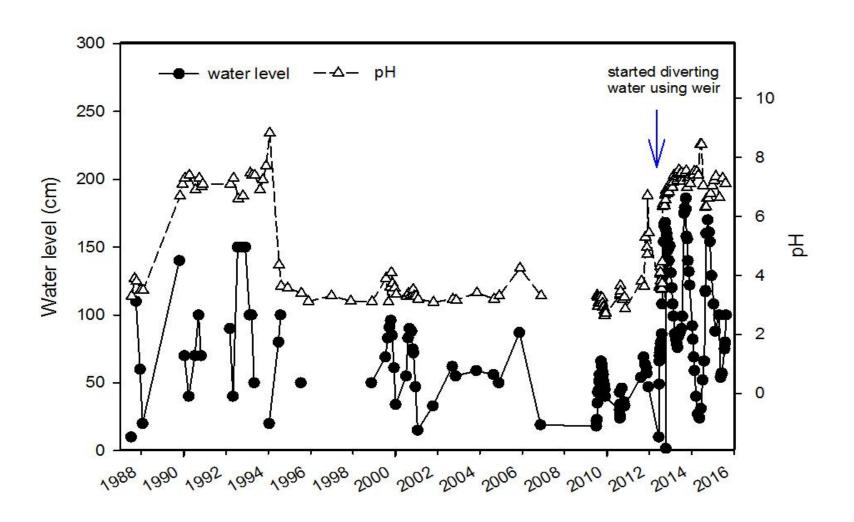
#### Water levels & pH recorded from 1989 to 2015

- 1994 2012, the lake dried out every year
- Reduced rainfall and changes to drainage management, including closing a shallow channel that connected the lake to the Mealup Main Drain (MMD) and its catchment
- Water became acidic (pH 3 to 4); algal blooms
- Waterbird numbers and species declined
- Frogs disappeared & very low macroinvertebrate diversity
- Typha orientalis expanded, covering 80% of lake bed by 2000

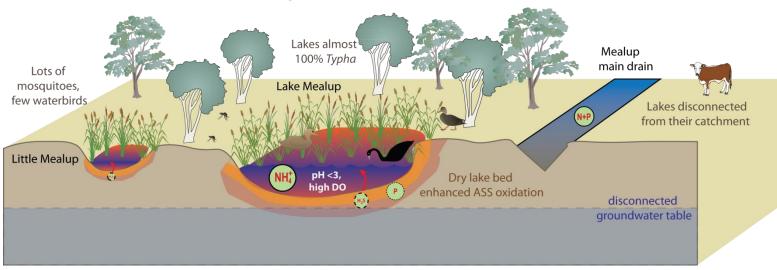
### Conceptual Model
