Recent innovations in microbat mitigation on road projects in NSW

Josie Stokes – Biodiversity officer, NSW Roads and Maritime Services

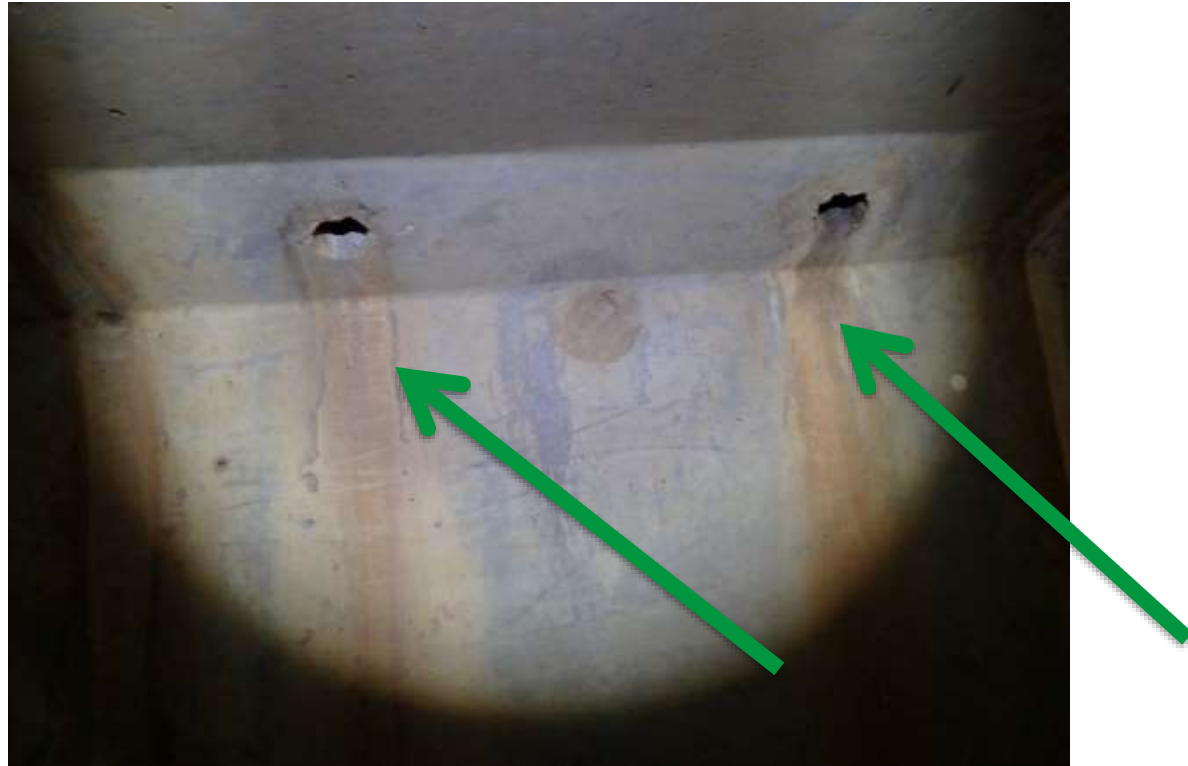
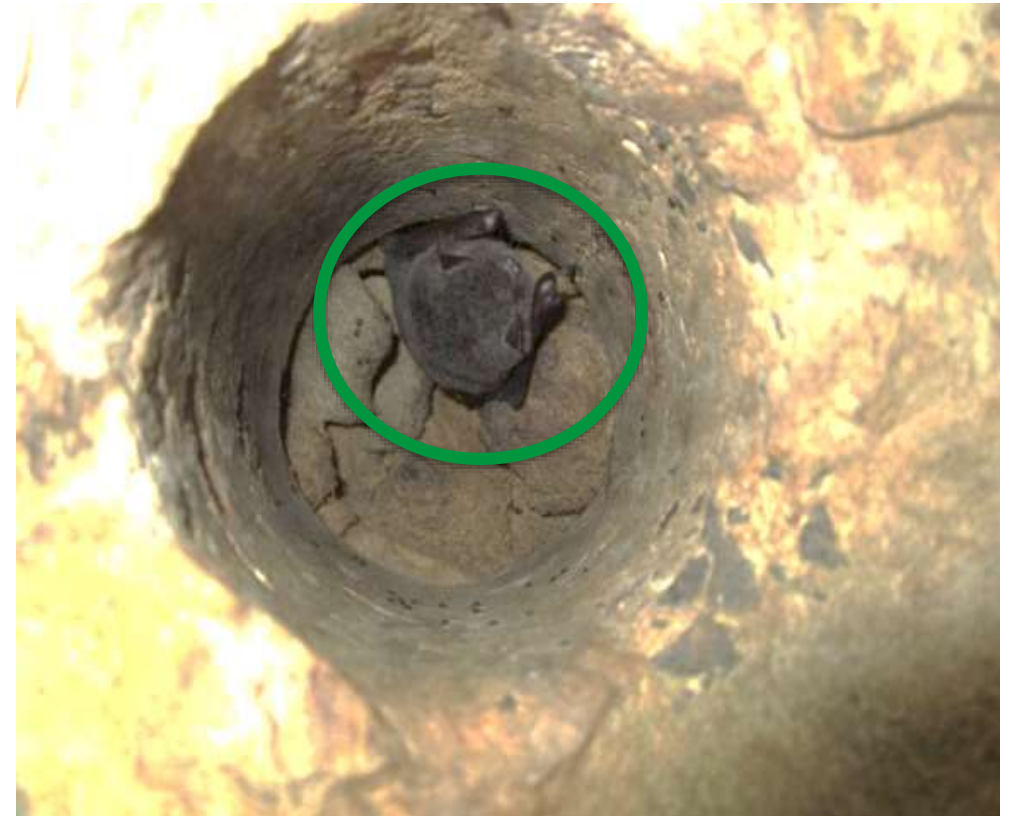
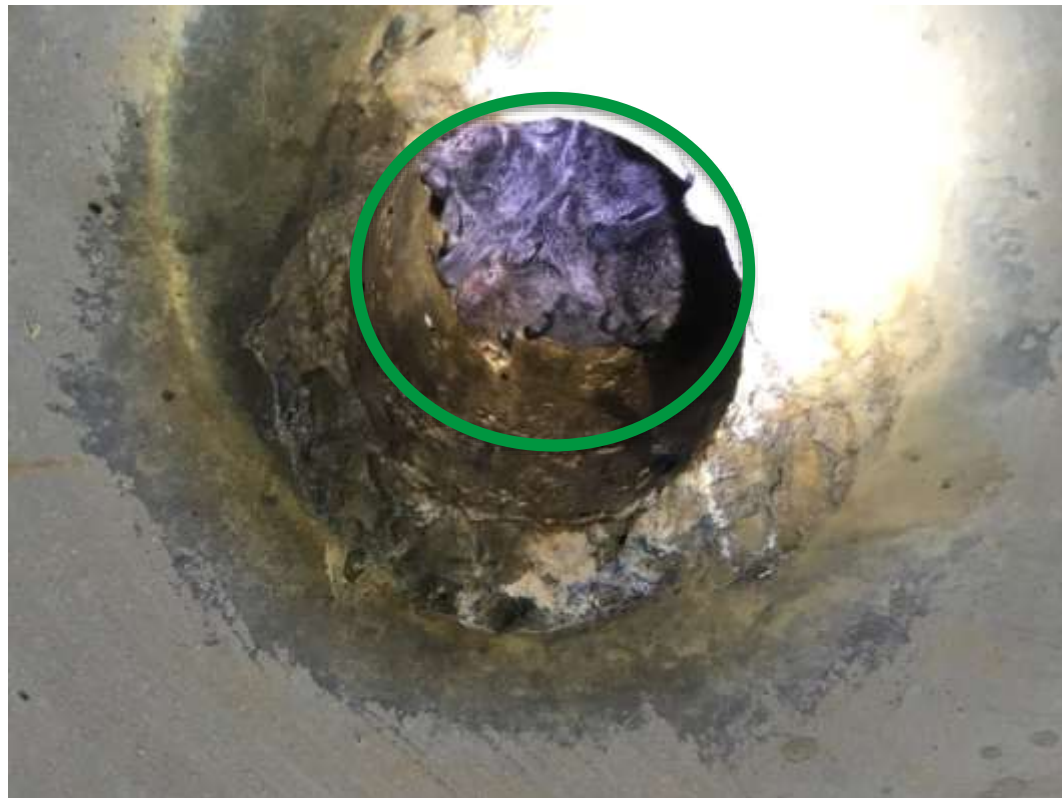
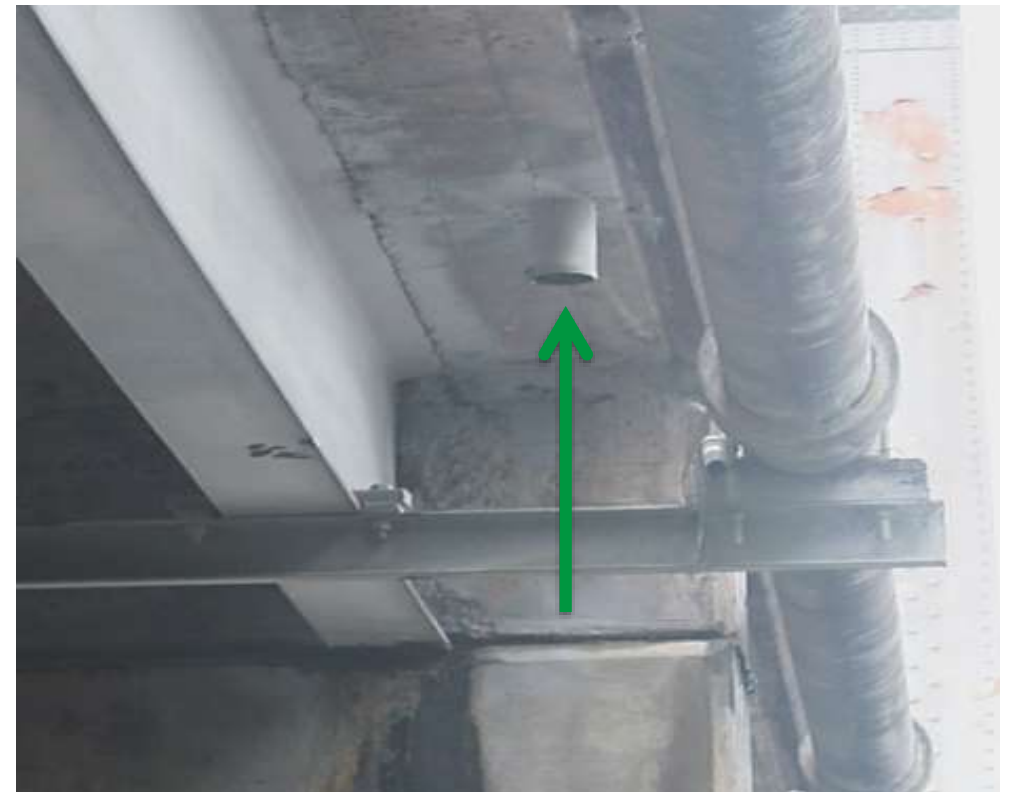
Culvert lift points and drainage scuppers

- Small, dry crevices in structures **over water or within 100-200m of flowing water.**
- Fairy martin nests, paper wasp nests
- Culvert lift/grab points and drainage scuppers
- Expansion gaps between bridge deck planks
- Roughened and exposed concrete
- Timber bridges

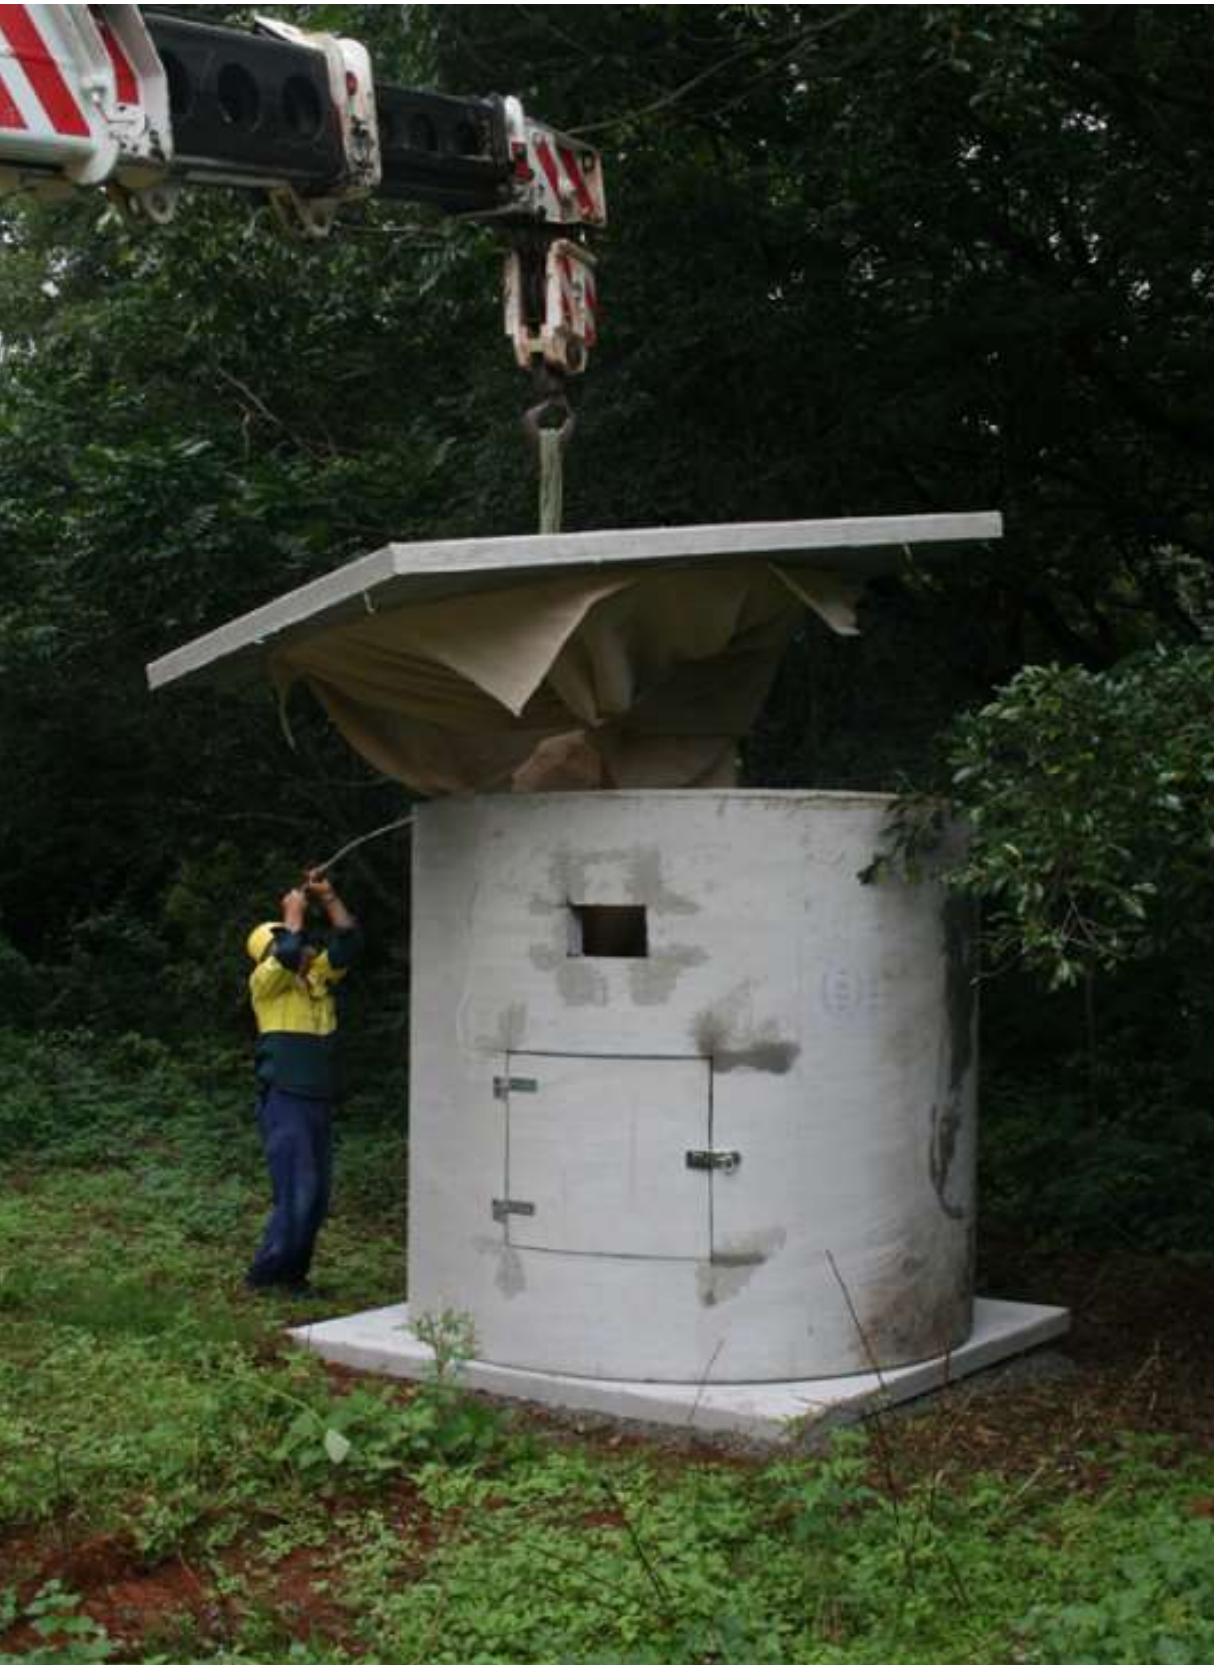
The 'Bat Caves' – did they work?

NO.....

5 concrete pipes placed into open farm paddocks (with no running water) to mimic concrete culverts.

No uptake by target threatened species (Myotis)

Uptake by some hollow tree dwelling (common) species

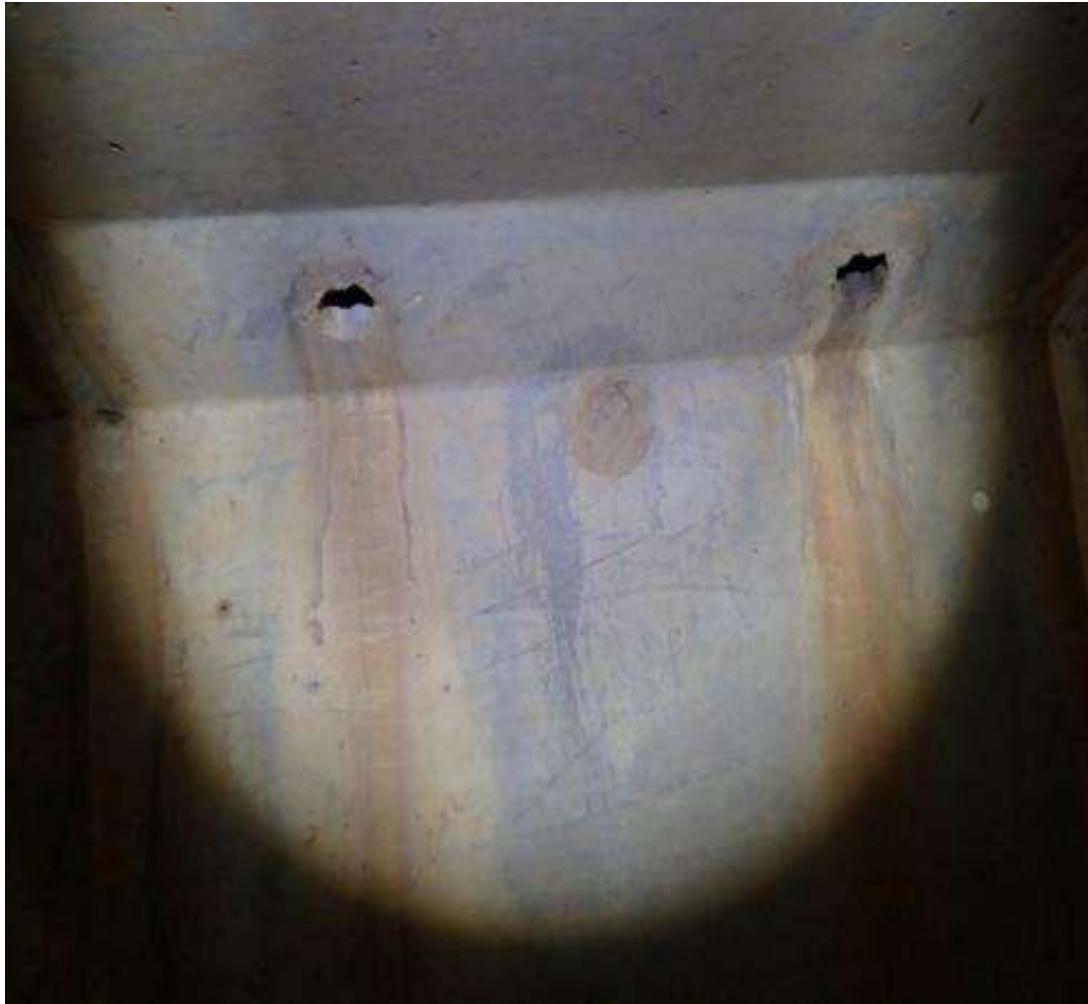
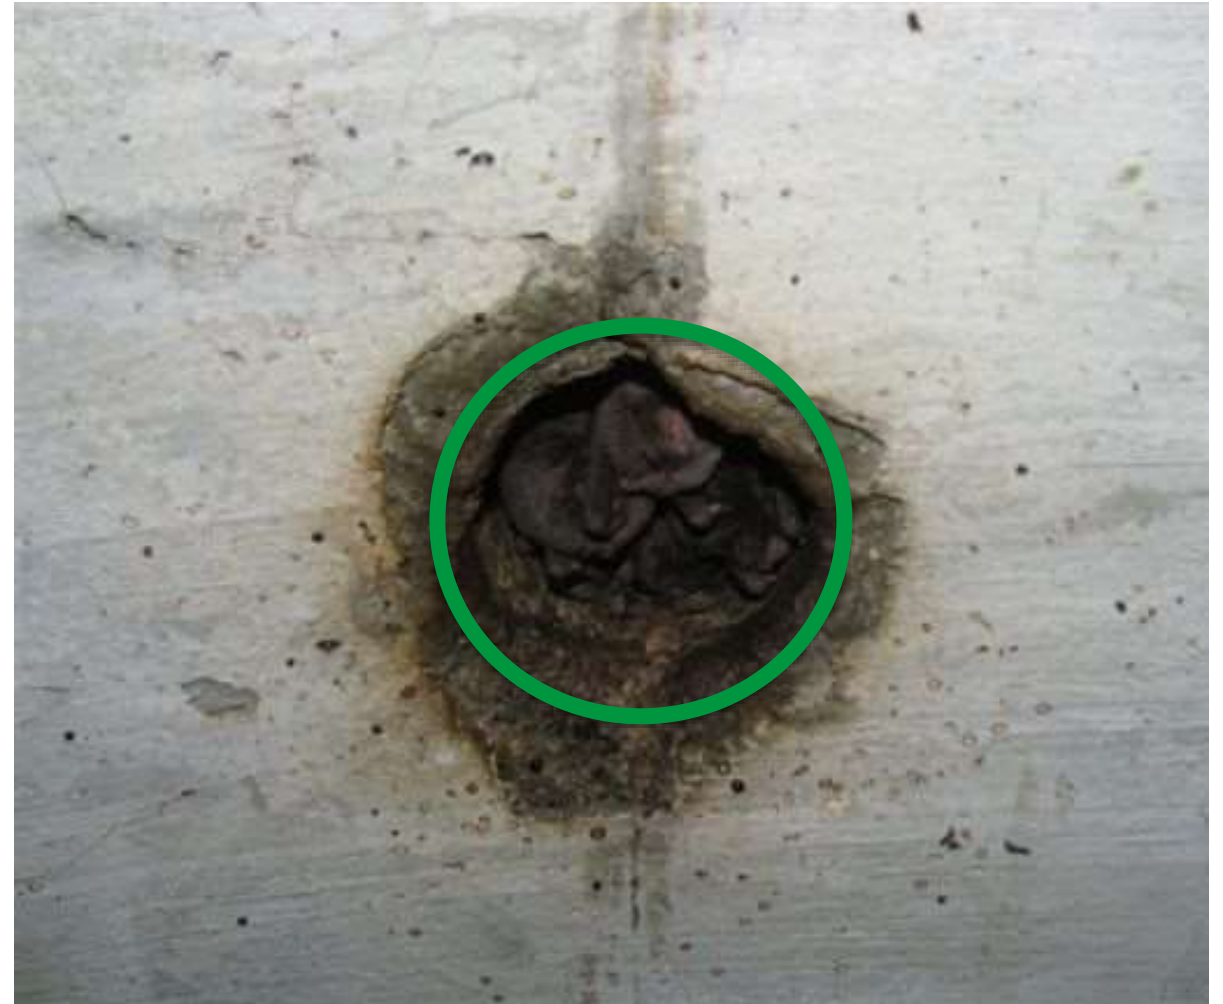
3. Replicate microbat roost features into culvert relining

- Large-footed Myotis – 122 (breeding and roosting habitat)
- Eastern Bent-winged bat- 100 (non-breeding roosting habitat)
- Little Bent-winged bat- 19 (non-breeding roosting habitat)

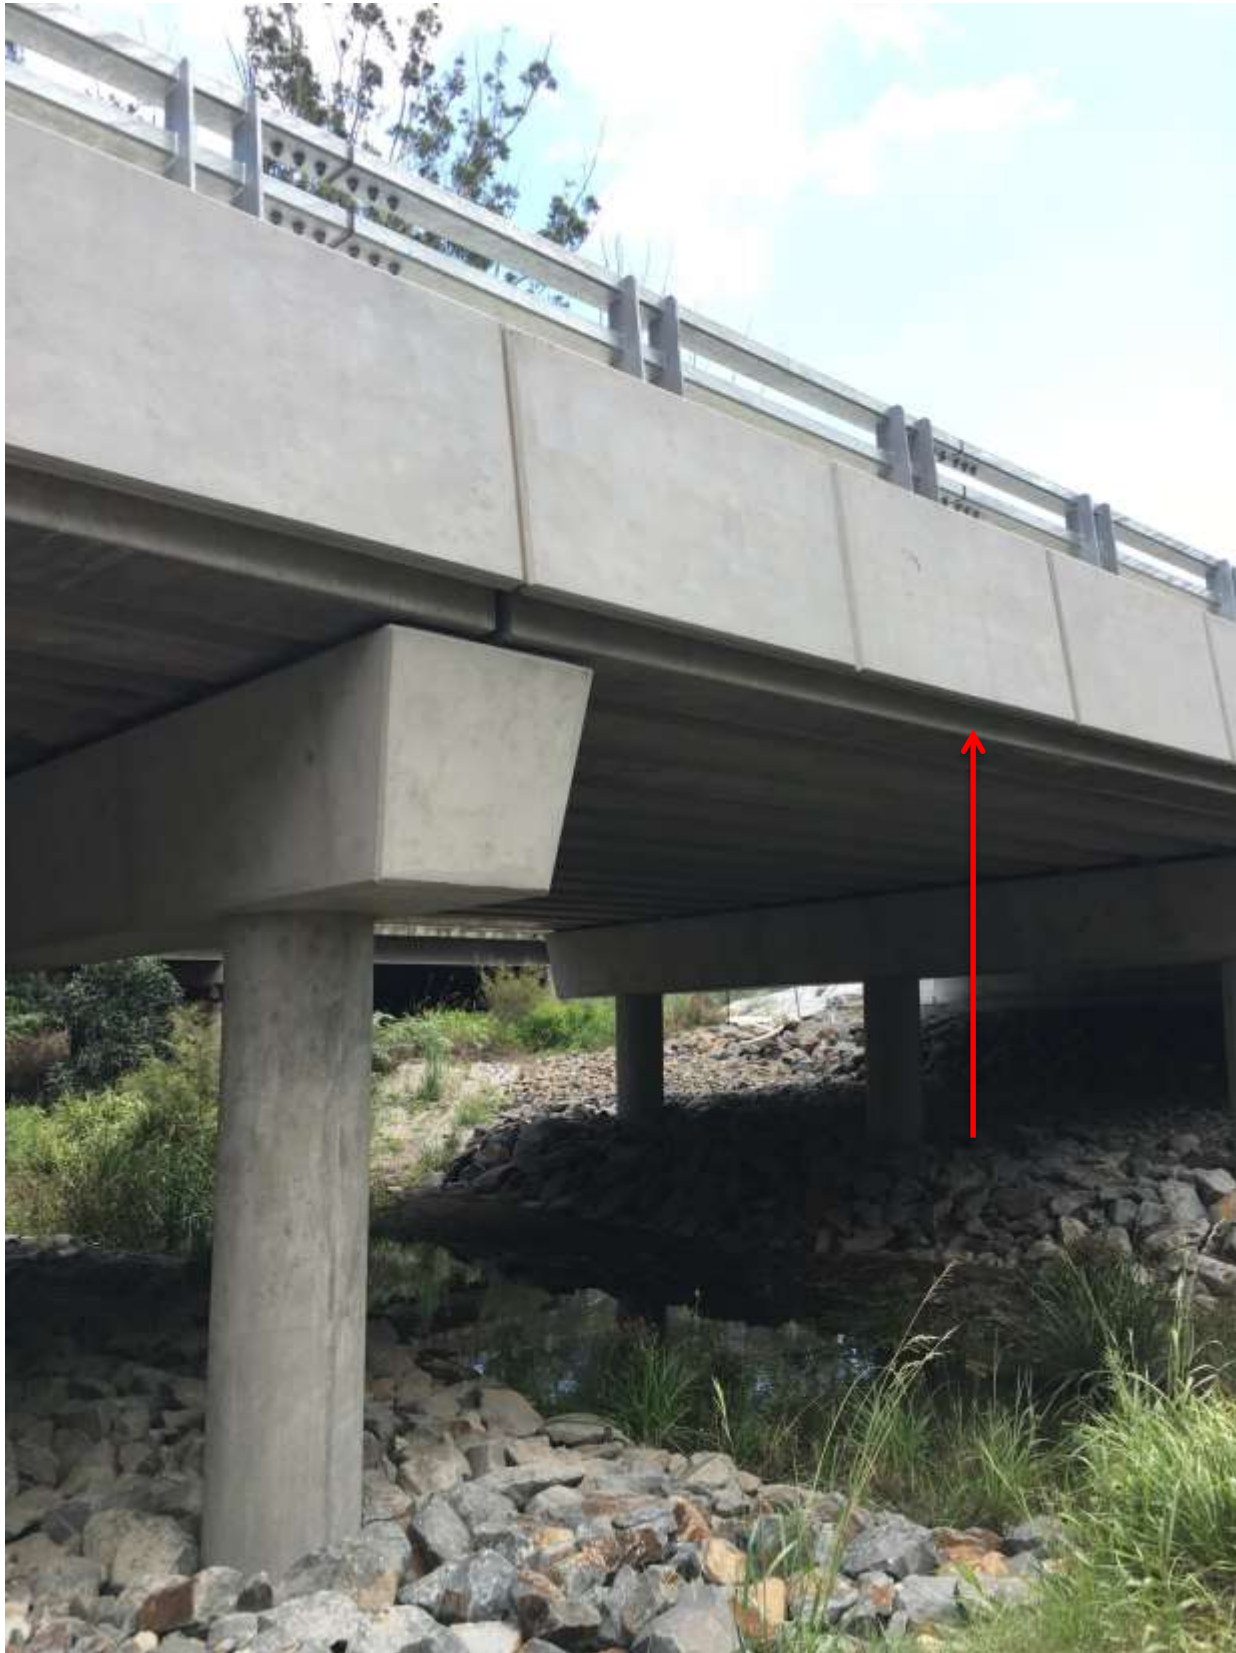
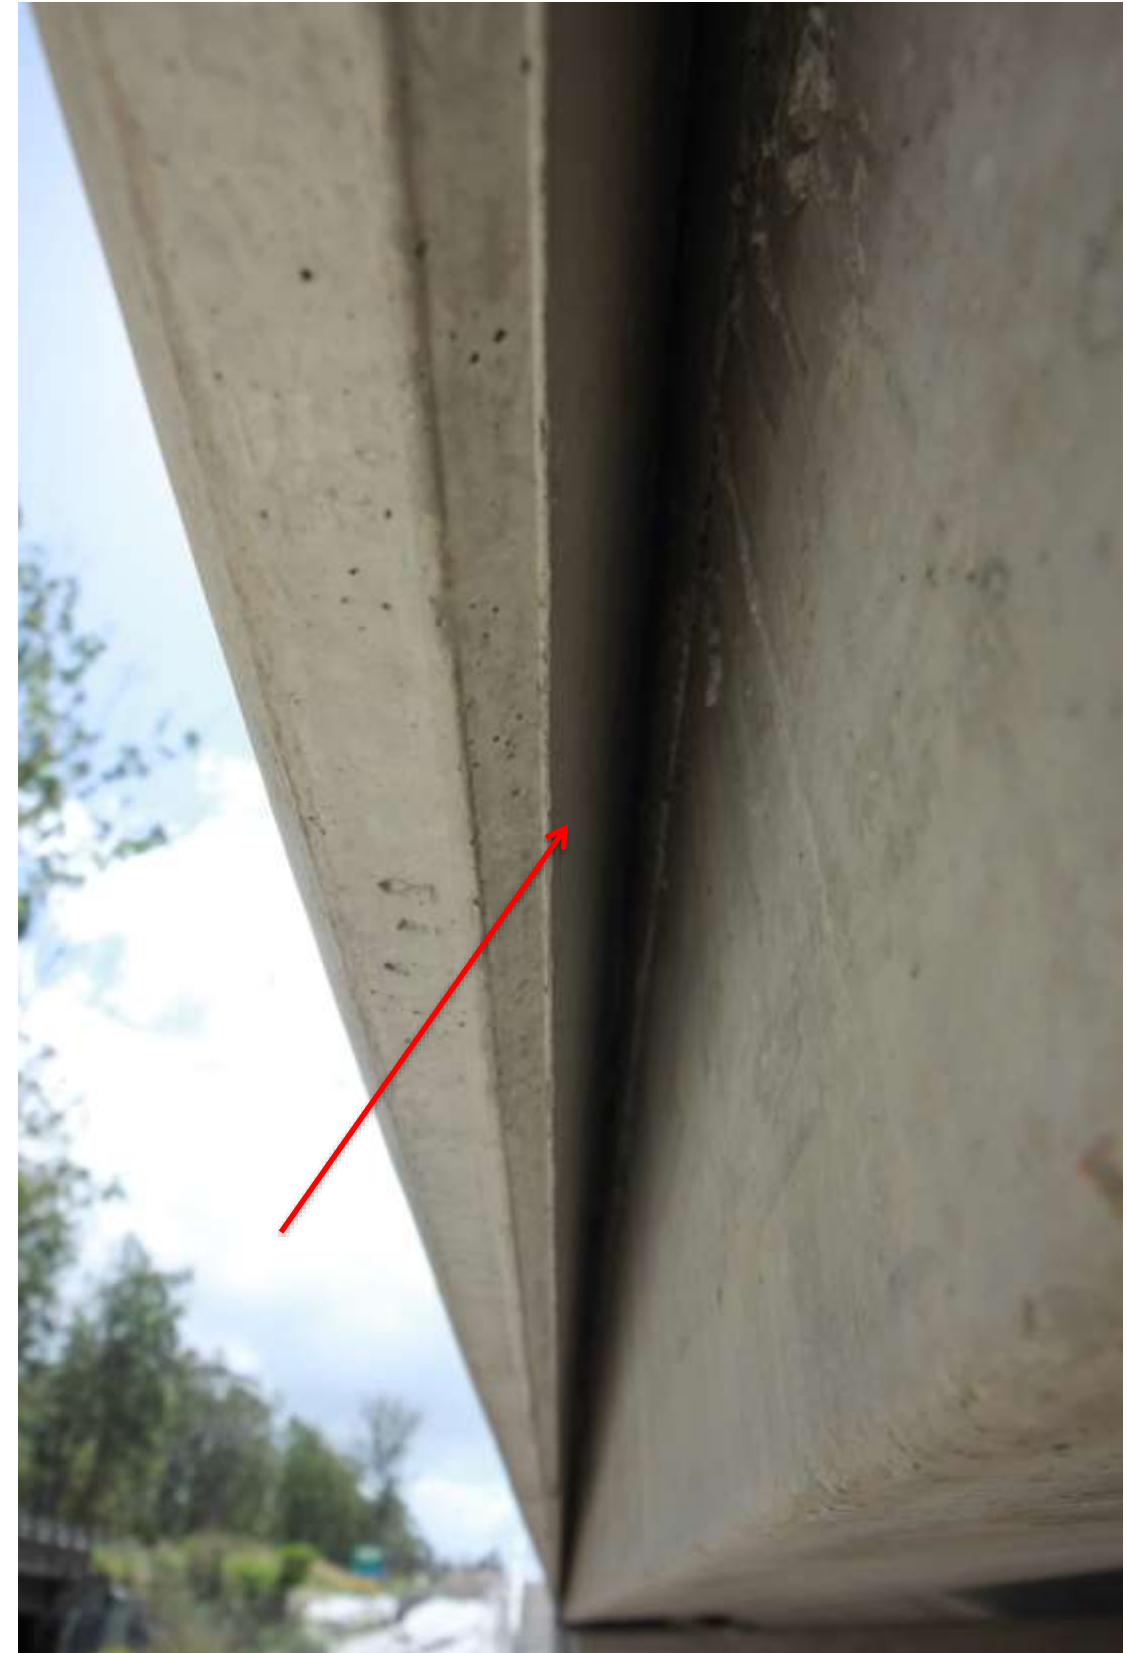
Scabbling of the parapets

A close-up photograph of a concrete parapet surface. The surface is heavily textured and shows significant scabbling, with many small, dark, irregular fragments of concrete exposed. The background is slightly blurred, showing a horizontal line and a yellow safety tape.

Use Rugasol to roughen surface to in casting yard

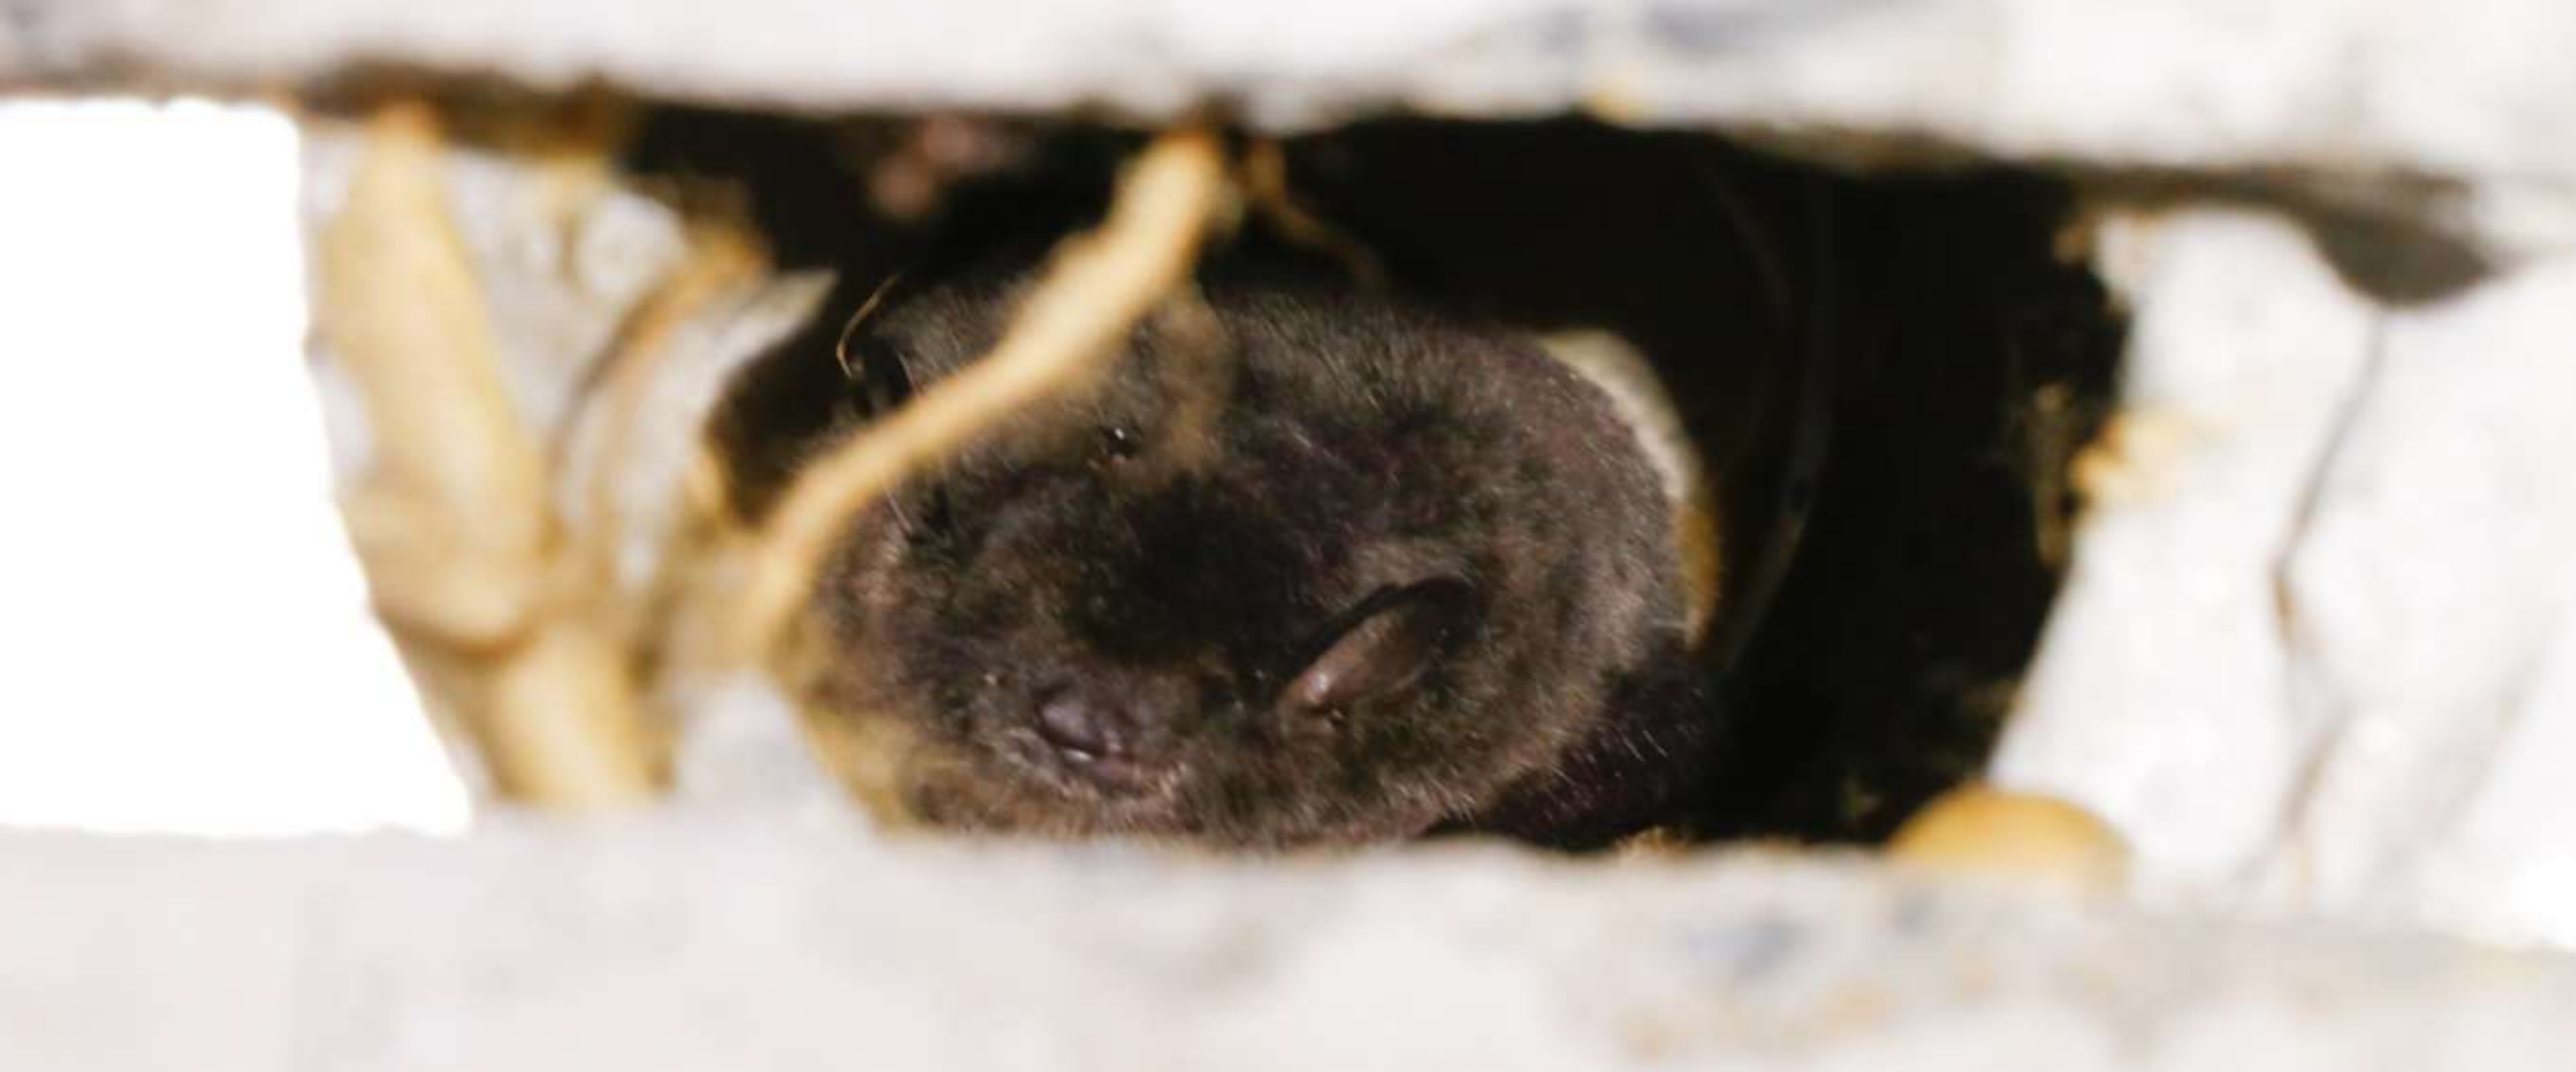
NEVER TRUST A BAT!

8 Large-footed Myotis in permanent breeding habitat under the Super T deck but not the shared pathway. WHY?

**90mm vs 50mm entry diameter?
Not roughened at entry?
Too exposed?
Too soon to tell?**

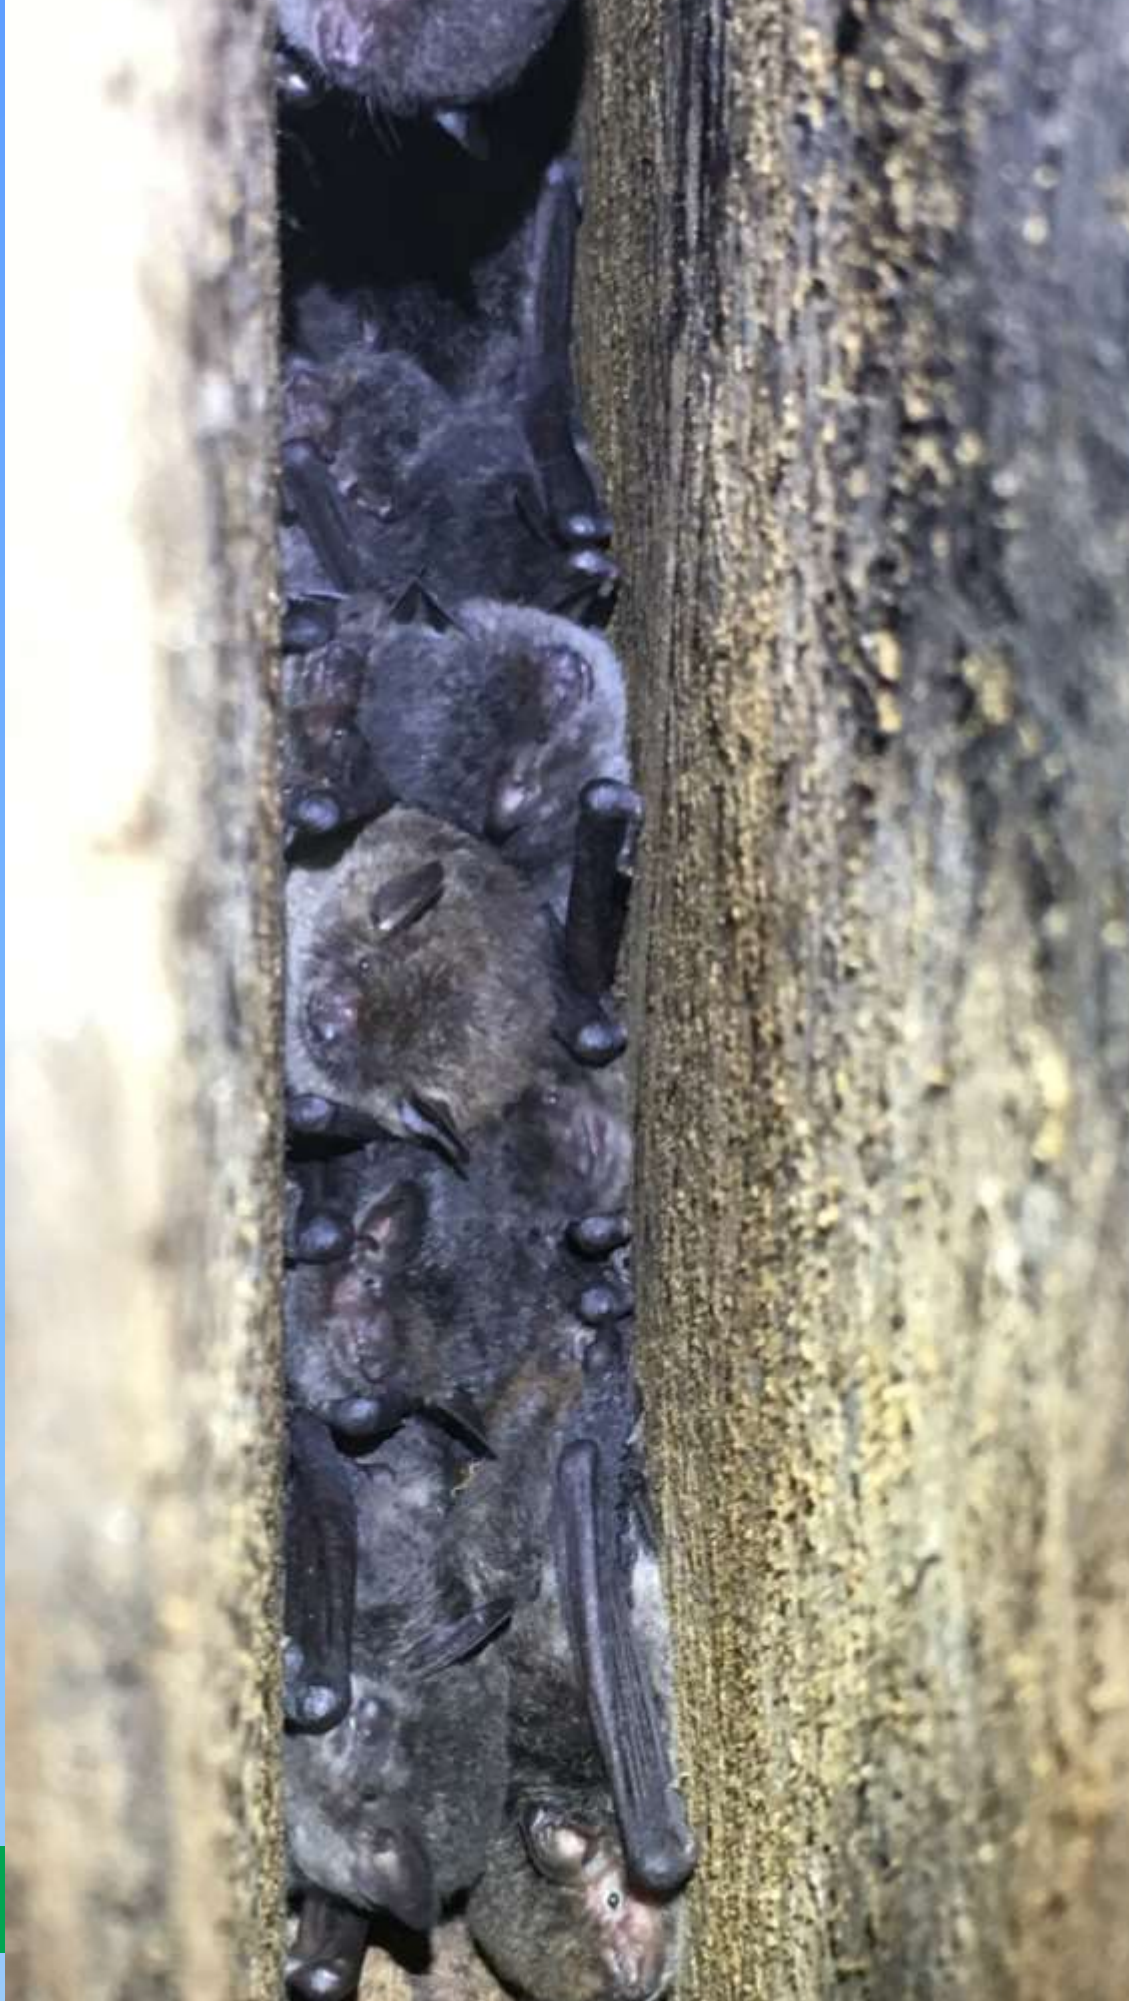
Split stringer breeding habitat:
35mm gap x 20-25cm long
